Bern, 31 May 2012

Validation Study of the Lufft Ventus Wind Sensor

Test Measurement and Validation on La Dôle in the Jura Mountains, Switzerland

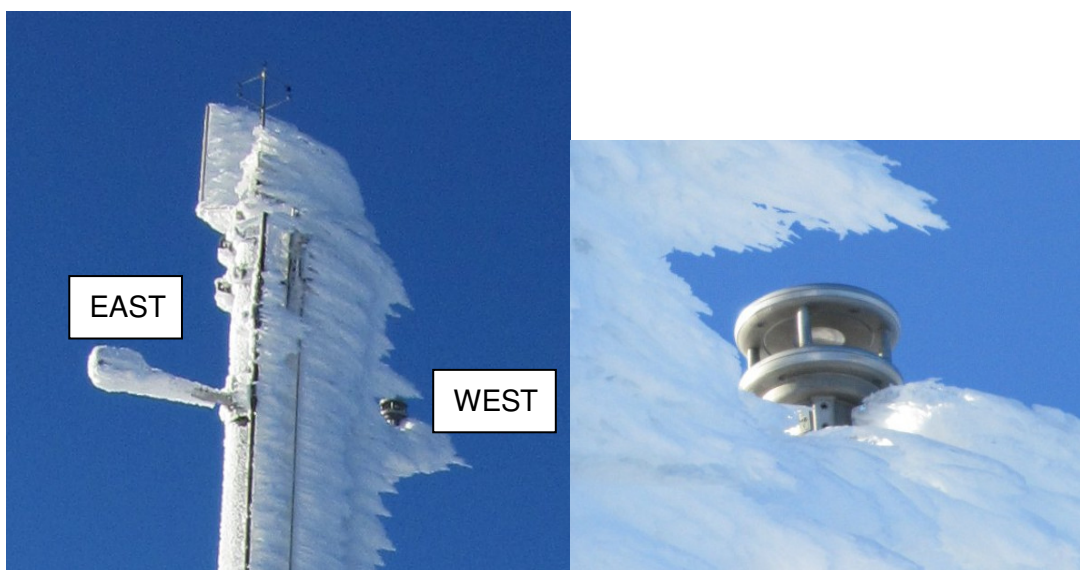
Figure 9: Left: Top of mast during a heavy icing event on 10.1.2012. Right: Zoom on Ventus wind sensor.

Figure 9 shows a photograph of the top of the mast on the morning of 10.1.2012 during a heavy icing event. There is a strong build-up of ice on the west side of the mast. The reference wind sensor protrudes above the ice whereas on the west side the Ventus wind sensor on the lateral arm is surrounded by ice. Although the actual sensor is ice-free, it reaches very close to the ice on the lateral arm. When the wind blows from the east, the sensor lies in the wind shadow of the ice formation; it is ice-free on the west, north and south sides.

In Case Study 1, this was clearly shown with the aid of photographs. The images demonstrate that, despite severe icing, the Ventus remained ice-free, although heavily influenced by ice formation on the lateral arm.
